CERTAIN 2006-2009 MKZ/ZEPHYR VEHICLES – PASSENGER AIRBAG MODULE REPLACEMENT

OVERVIEW

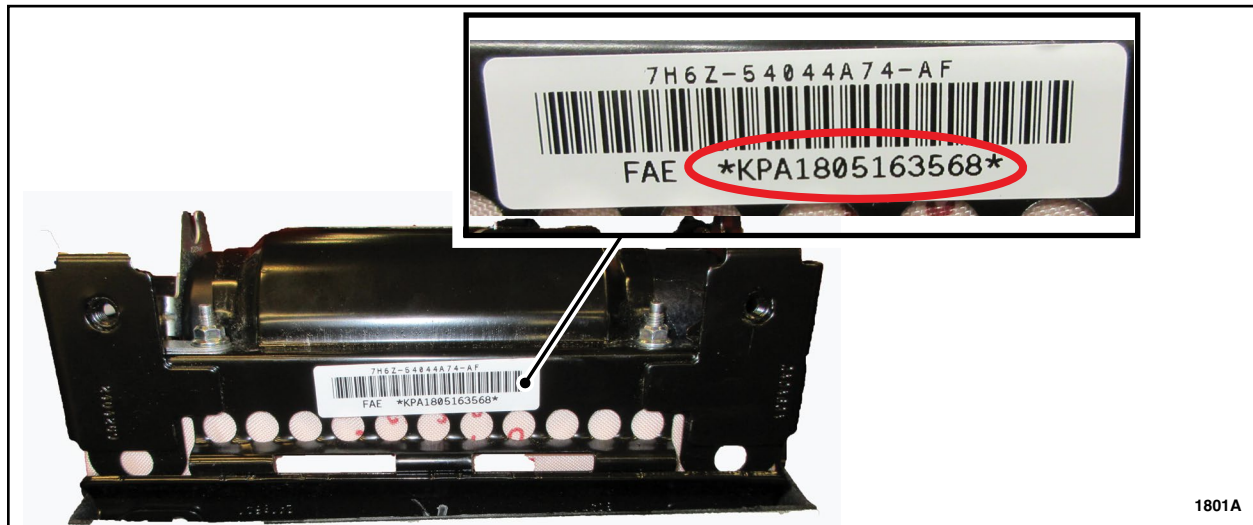
FIGURE 1

1. Record the 13 character serial number of the new airbag module on the repair order. See Figure 1.
2. Replace the passenger airbag module. Refer to section 501-20B of the Workshop Manual.
